LONDON AND NORTH-WESTERN RAILWAY.

IN compliance with the instructions contained in your minute of the 8th instant, I have the honour to report, for the information of the Lords of the Committee of Privy Council for Trade, the result of my inquiry into the circumstances which attended the accident, that occurred on the 4th instant, near the Rugby station of the London and North-western Railway.

To accompany Captain TYLER'S Report, dated 30th July 1861, on the bursting of the Boiler of No. 249 Engine, attached to the Irish Mail Train, near Rugby, on the LONDON AND NORTH WESTERN RAILWAY, on the 4th July 1861.

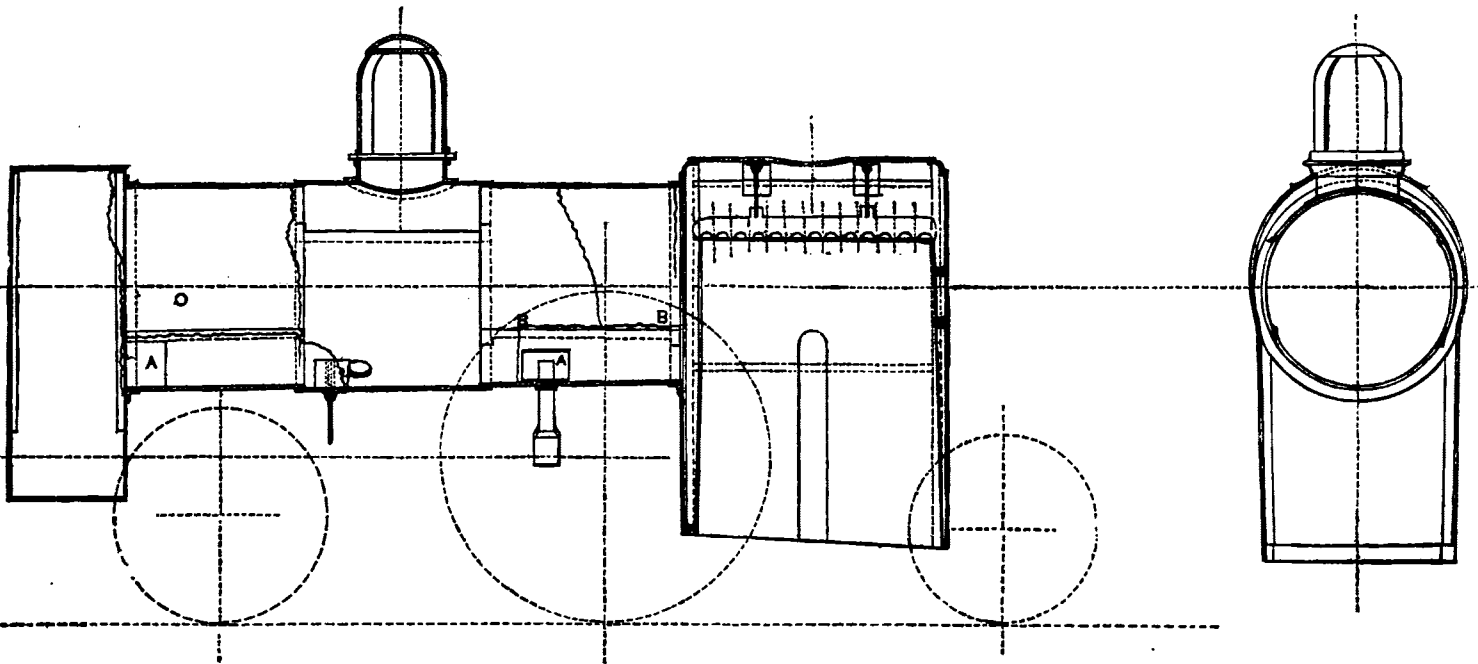
FIG. 1.

Those lines of fracture are clearly shown on the diagrams Nos. 1 and 2 enclosed herewith, the former having reference to the right, or off—the latter to the left, or near side of the engine. The different portions, also, into which the barrel of the boiler was divided, are shown in diagrams 3 to 9 inclusive; and the off driving wheel, with the portions that were blown away with it, in Nos. 10 and 11. These diagrams, which are interesting and important, in demonstrating the cause, and illustrating the effects of the explosion, have been kindly furnished to me by Mr. McConnell, the locomotive superintendent for the Southern division of the London and North-western Railway, and have been prepared by the officers of his department.

Longitudinal Section showing lines of fracture on right side.

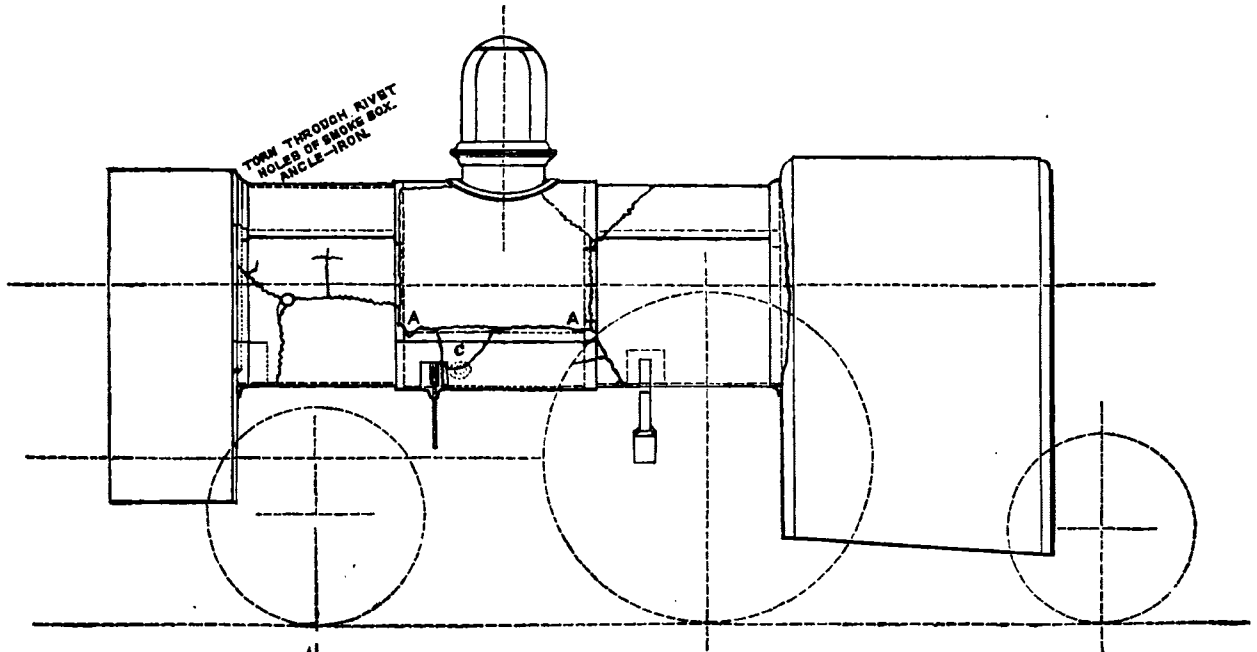
FIG. 2

Longitudinal Section showing lines of fracture on left side.

In examining the fractured portions of this boiler, I observed that corrosion had been actively going on in several parts of it, and particularly above two seams of rivets, the one situated on the left side of the middle ring, and marked A A in the diagrams Nos. 2 and 8; and the other on the right side of the firebox ring, marked B B in diagram No. 1. The former was the worse of the two lines, and was the weakest part of the boiler. The metal had been eaten away along this line in an irregular manner, and had been reduced in places, to little, if any, more than ⅙th of an inch, which, as I have before shown, would approach closely to the thickness at which rupture might be expected at the ordinary working pressure of the engine.

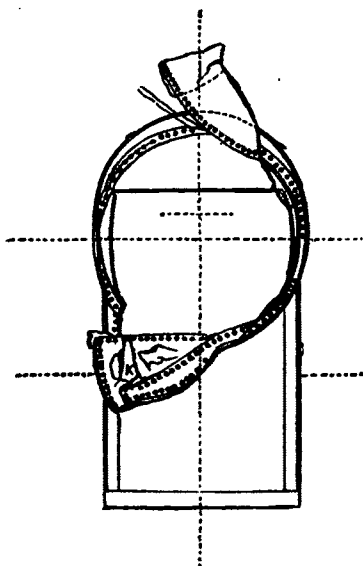
FIG. 3.

End elevation of fire-box, as seen from the front, with remains of fire-box ring attached.

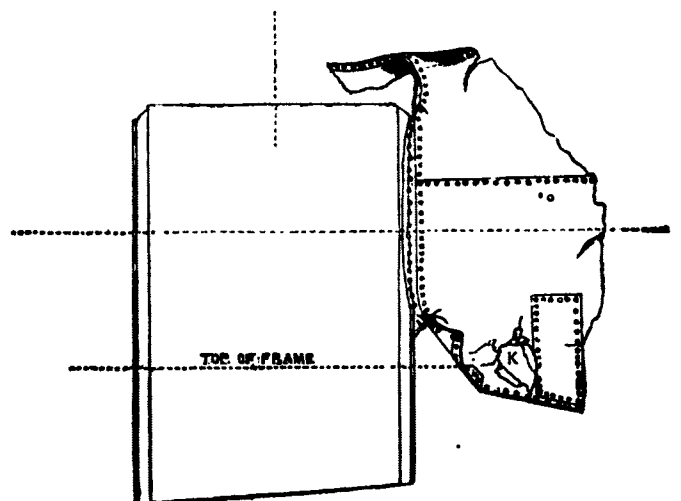
FIG. 4.

Side view of fire-box, and remains of fire-box ring of barrel.

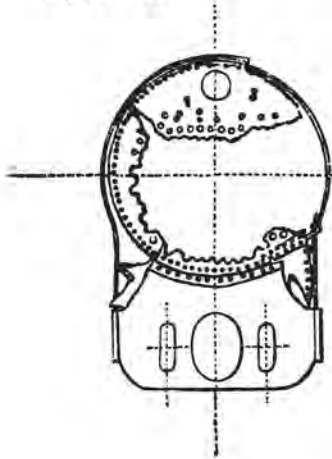
FIG. 5.

End view of smoke-box, as seen from behind, with remains of tube-plate, and small portions of smoke-box ring of barrel.

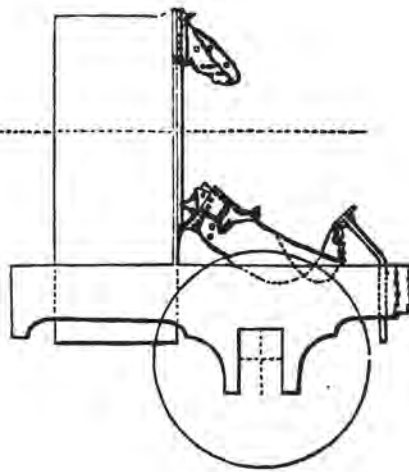
FIG. 6.

Side view of smoke-box, with portion of barrel attached.

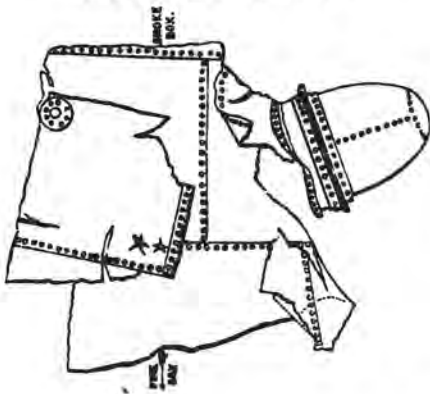
FIG. 7.

Larger detached portion of middle ring of barrel, with steam dome attached.

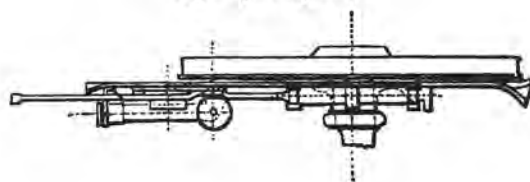
FIG. 11.

Plan and elevation of wheel and part of framing of No. 249 engine after explosion.
